Franklin Street Train Station, Reading, PA

Franklin Street Train Station

THE RESTORATION PROCESS

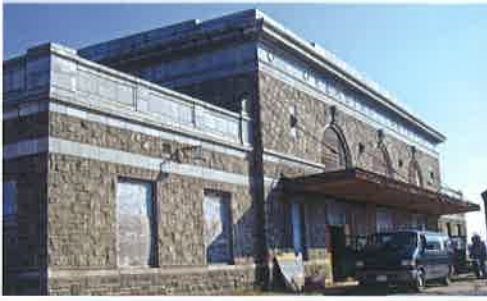
Before

From 1981 until 2011 the building sat abandoned. Vandals, several fires, and animals damaged the building. The exterior stone walls were covered in graffiti, windows were broken or missing, wood rot was extensive throughout, plaster was damaged from the leaking roof, and the original train station benches were long gone.
