Restored Pennsylvania Train Station  
Transports You to Another Time.

# Station On Track.

**PROJECT:**  
**Franklin Street  
Train Station  
Restoration**  
Reading, PA

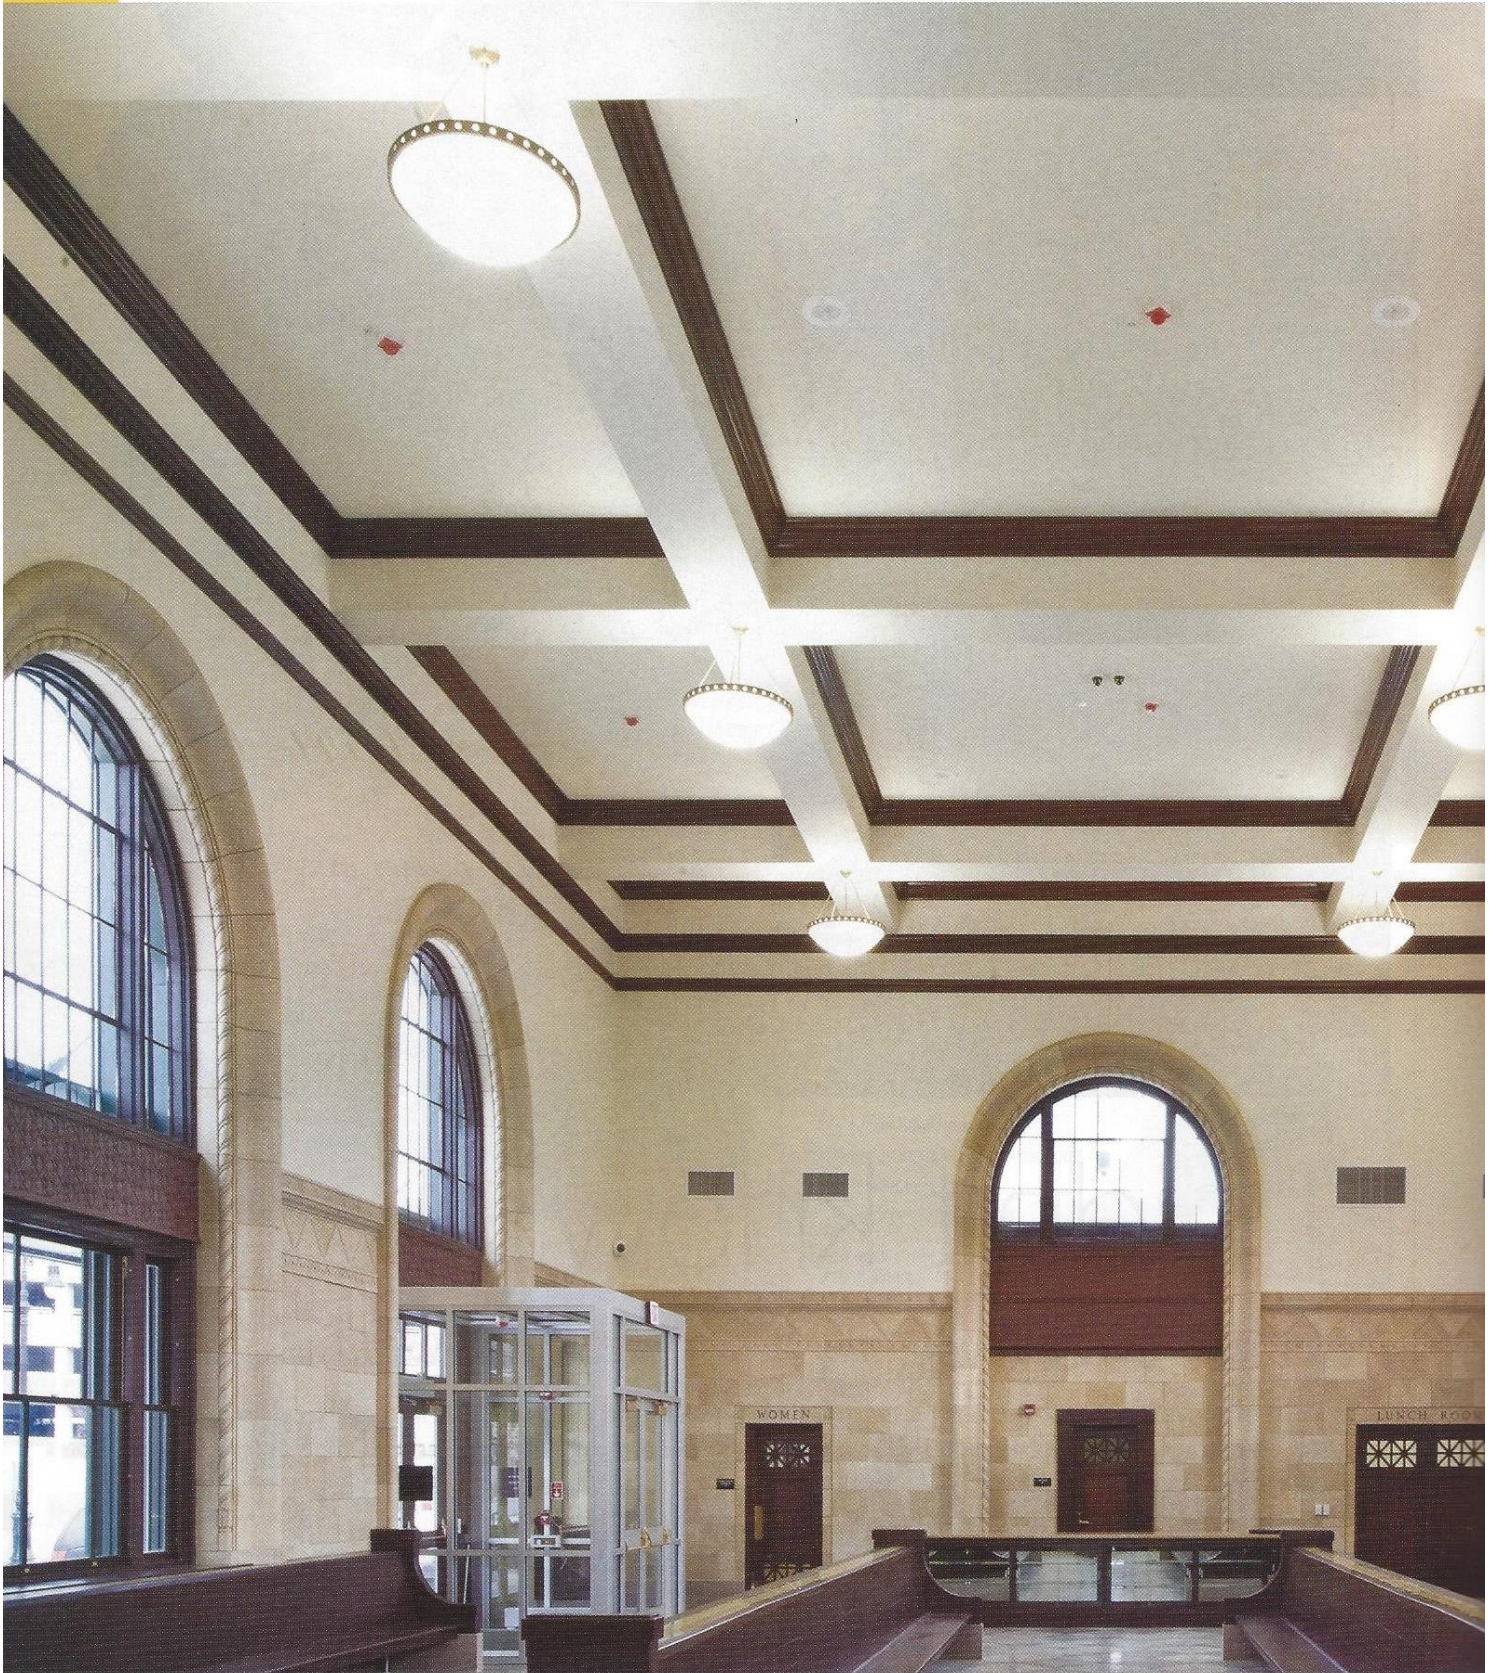
The beautifully restored coffered ceiling presented a millwork challenge.

Chuck Groshong of Historic Restorations reports one of the biggest architectural woodwork features on the project was the coffered ceiling the firm recreated to match what had been there originally. “Thirty feet above eye level, the ceiling wasn’t just decayed beyond revival, it had been completely removed. The process began with extensive work on the design of the cornice profile. The challenge was not only coming up with a design that was historically accurate, we also needed to proportionally enlarge the profile so it could be seen from below.”

The woodworking firm contributed a lot of assistance in helping the crew meet scheduling and budget objectives. “We employed an out-of-the-box approach to installation of the coffered ceiling that saved time and money,” points out Groshong. “By installing scaffolding that covered the entire inside of the building, we were able to install the ceiling in a little over a week.”

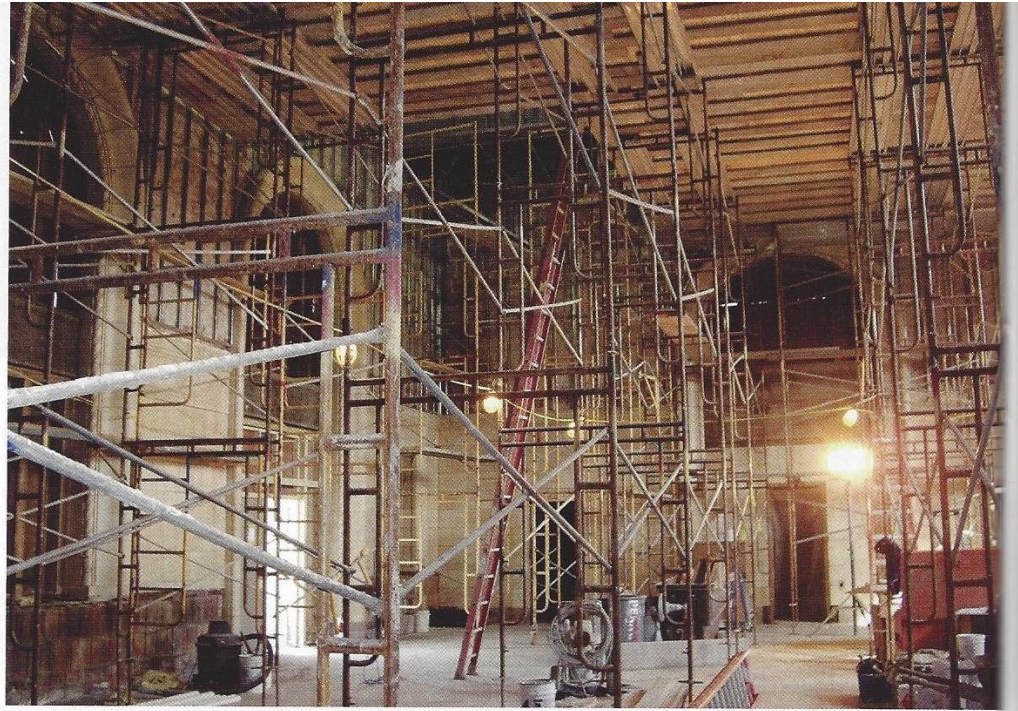
Through teamwork, the end result was a cornice profile of Yellow Pine that was almost four feet thick.
